**Calvary Riverina Hospital**  
Sterilisation Unit Transport Van  
Risk Assessment Report  
April 2021

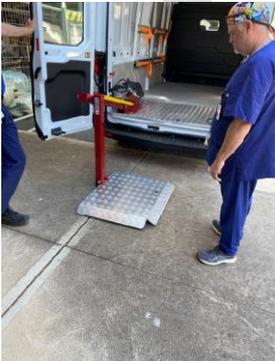
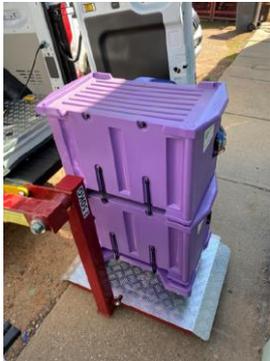
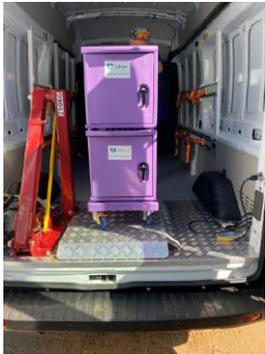
The new van has been fitted with a lifting platform to lift cases in and out of the van, reducing the requirement for Calvary workers to physically lift cases in and out of a vehicle. Concerns were raised about the risk of the dolly and cases falling off during a lifting or lowering movement. It is our opinion the likelihood of this happening is extremely low given the speed of the lift and locked two wheels. The operation mechanism is a 'dead-man' style switch that ceases the movement of the lift as soon as the switch is no longer manually held in place.

A lengthy discussion occurred regarding the sloped edges of the lifting platform and the ability to easily roll the dolly and cases up the slope and onto the platform. Given the cases are estimated to weigh 12kg each when loaded (relatively light), and it wasn't conclusive from workers that it was difficult the suggestion from the Recovery partners consultant was to trial it for 3 months and then verify if it was an actual hazard or simply a perceived one. In the event it is an actual issue (any rolling of equipment from ground level to a lifting platform will have a transitional bump or slope of some degree) the following recommendations are given:

<p>Lifter and van</p>	<p>Dolly and 2 x cases on lifter</p>	<p>Dolly, cases and lifter on van</p>

A suggested recommendation to further reduce risk is to install two eye-bolts (or similar) to the Auslift platform and ratchet strap the cases and dolly to the lift while being moved on the Auslift. This would need the manufacturer to investigate if possible.

1. Investigate from the dolly supplier larger diameter wheels to reduce the slope effects
2. Investigate from the Auslift supplier if the edges of the lift platform can be 'feathered' and the slope reduced
3. Introduce a two-person 'movement of the dolly and cases from the ground onto the platform

1. Install grab handles to assist in entering and exiting the van – front and rear areas.
2. Smooth concrete to bitumen transitions out where intended van parking bay is at hospital.
3. See Findings and consider a way to ratchet strap the dolly and cases to the Auslift lifting platform while it is being operated.
4. Use the current lifter and determine if the 'perceived' issue with the lifter edges and it difficult to push the dolly and cases onto the platform is actual or isn't an issue. If it is an issue investigate larger diameter wheels.
